DEPARTMENT OF NATURAL RESOURCES  
DIVISION OF OIL, GAS AND MINING

June 25, 1990

RE: North Lily Mine Inspection, M/023/007, Juab County, Utah

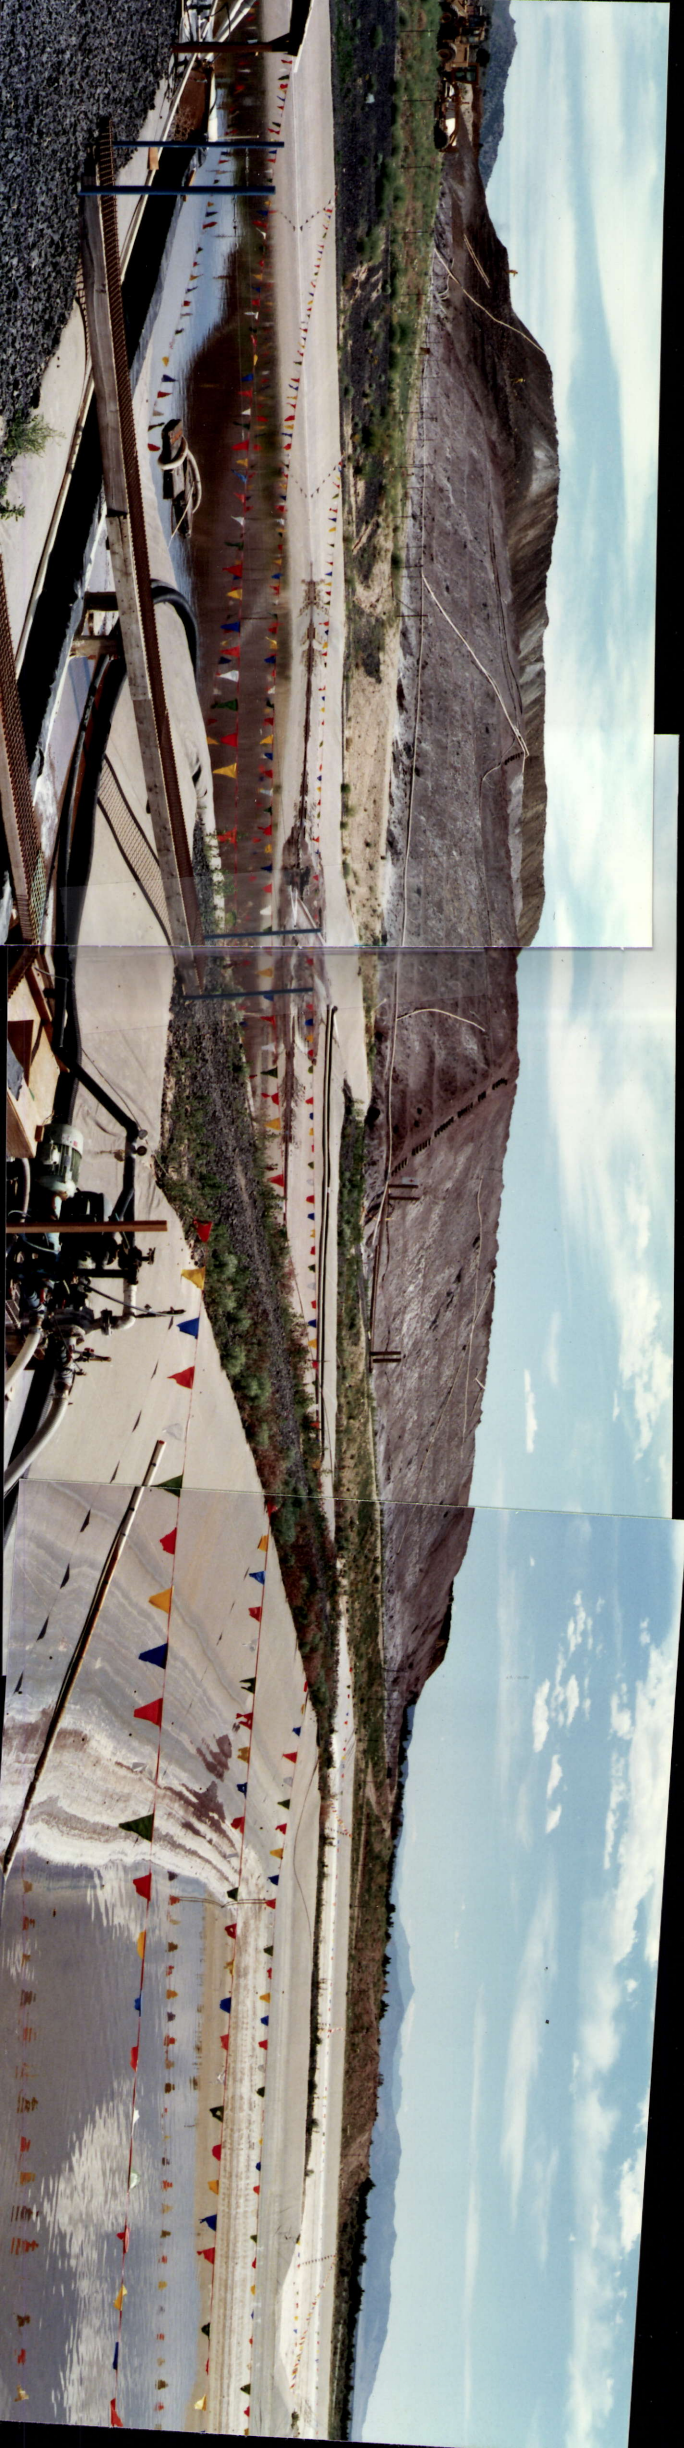
Leaching facilities

View S

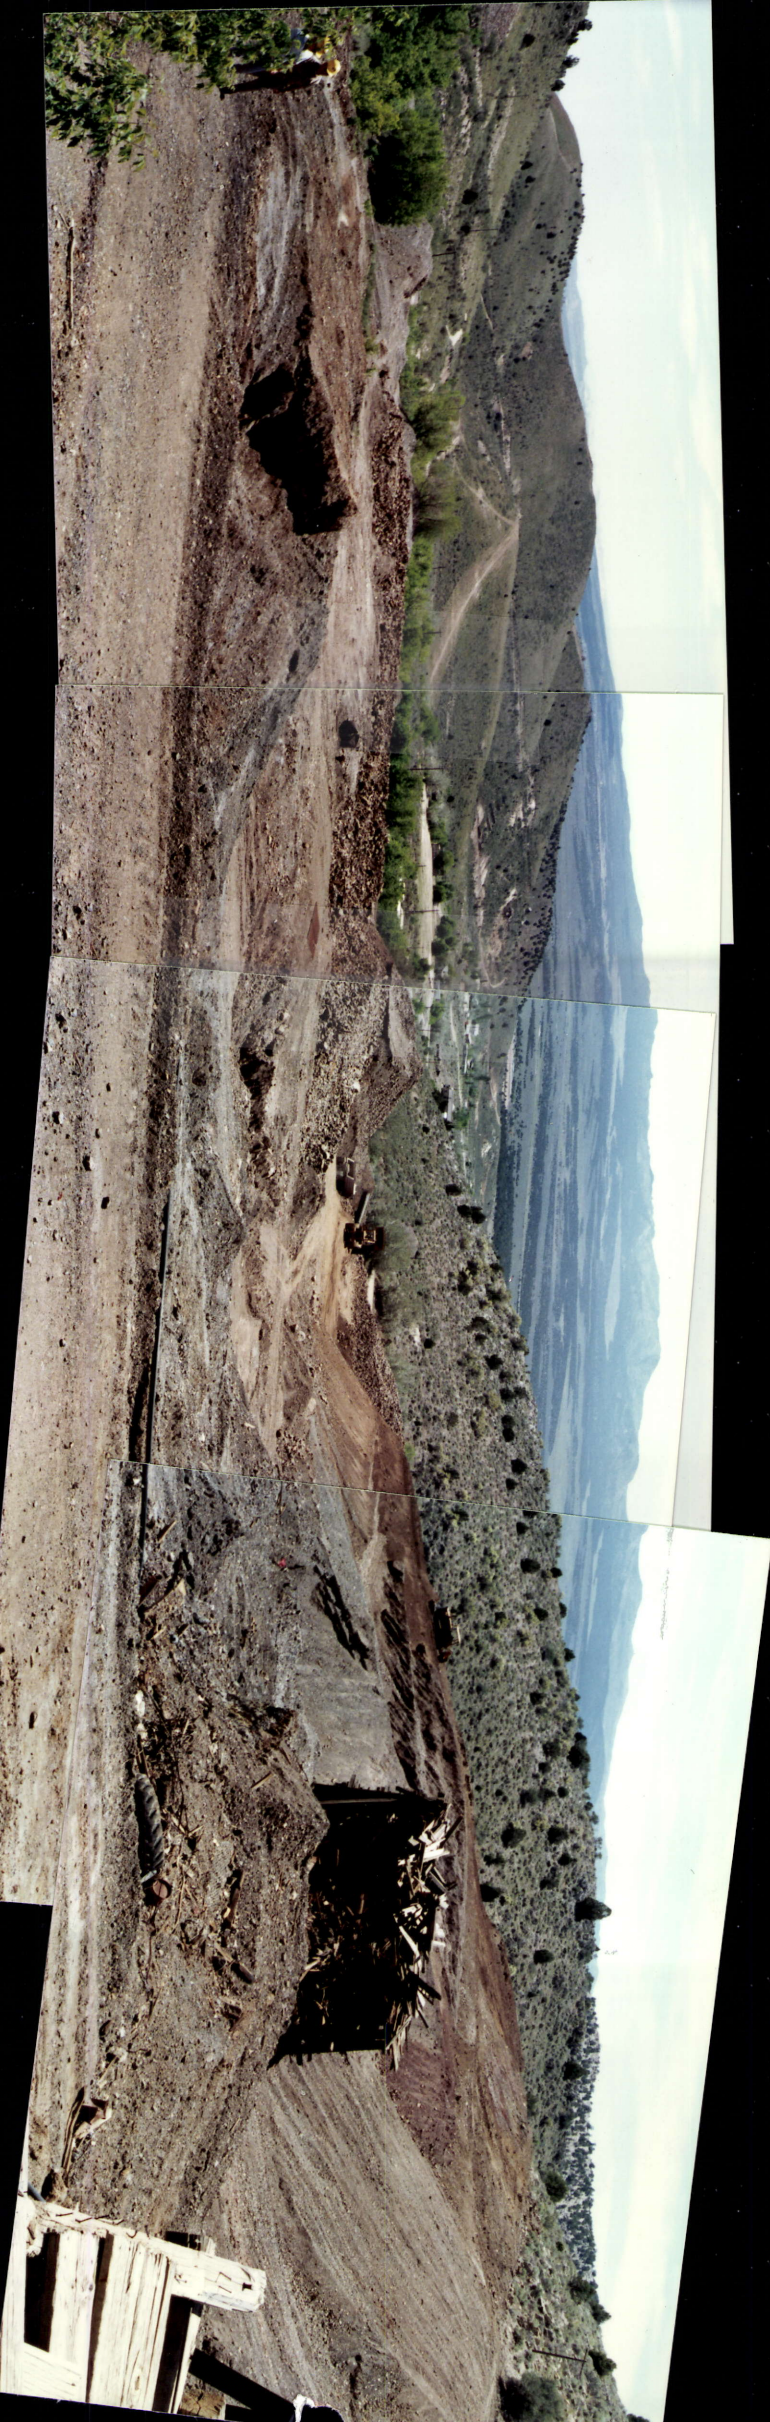
Mammoth Dump Salvage

View W

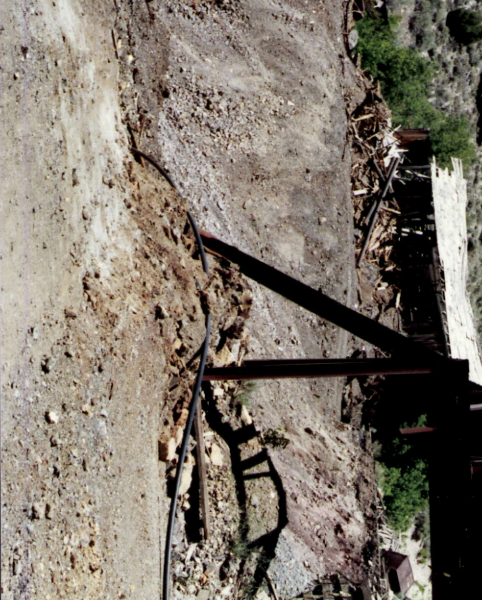
Mammoth Dump Area

View H
